Failure Analysis of an Exhaust Valve Spring Failed in Automotive Diesel Engine

Shivarama K
Department of Metallurgy,
Stumpp Schuele and Somappa Springs Private Ltd.,
Bangalore, India.

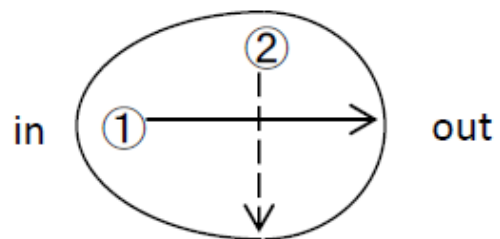
A hardness survey was made across the cross section of the metallographically prepared sample of the failed spring. The sample showed average hardness value of 582 HV, which is the acceptable criterion for the spring steel. Figure 12-13 shows the graphical representation of cross sectional hardness survey.

Fig.13.Schematic image of wire
