# Hintze Ribeiro Bridge Collapse: Mistakes & Lessons Learned

Fabricio Gaspar  
Coimbra higher institute of engineering  
Department of civil engineering

Individual article for obtaining credit in the discipline of Structural Analysis  
Supervisor: Eng. João Paulo Martins Gouveia

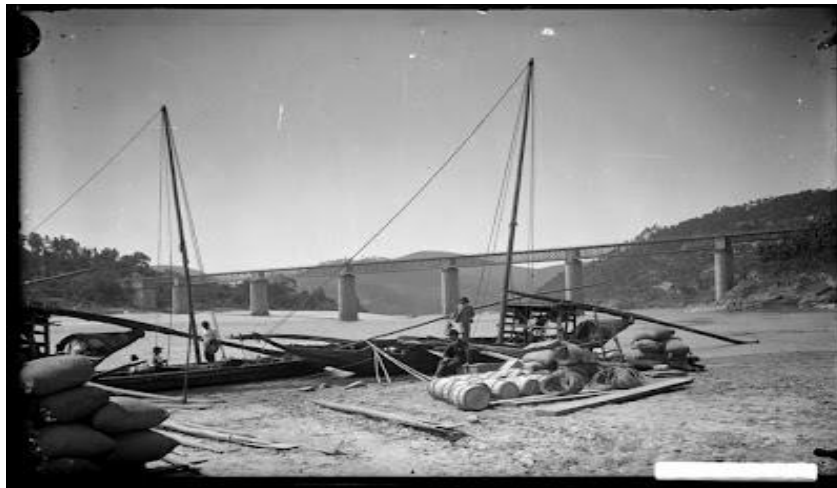
Figure 1.  
Hintze Ribeiro Bridge in 1908 - Phot.<sup>a</sup> Guedes.

From the photographs of the Hintze Ribeiro Bridge taken before the construction of the Crestuma-Lever dam, we can see a very small river flow and a huge sandbank. Furthermore, the structure was not immune to the country's historical events. During the Northern Monarchist Revolt in 1919, the bridge was partially destroyed by explosives, which caused significant damage to one of the pillars and the extreme section of the deck, close to the left bank of the Douro River, on the Castelo de Paiva side.
