Redesign of Plans for the Rehabilitation of Over-Flow Bridge at Barangay Cansan, Cabagan, Isabela

Dr. Noel D. Binag
Associate Professor

College of Engineering and Industrial Technology
Rizal Technological University, Philippines

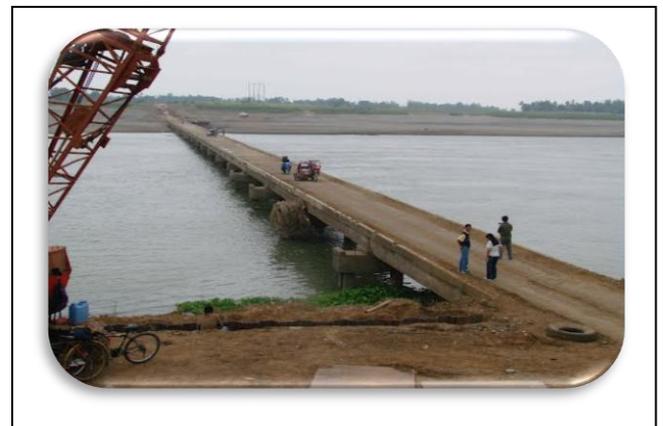
Figure 1: Cabagan-Sto. Tomas Over-Flow Bridge

completion of the bridge has brought a tremendous impact to the economy of Cabagan and Sto. Tomas. It also ended the struggles and suffering of people crossing the river through boat or barge. However, the bridge is not passable during heavy rains or typhoon strikes due to over flow of the water from the river. Moreover, after three years since the construction of the bridge, the super typhoon that occurred last October 2011 brought damaged to the bridge. Technically wise, the bridge is deteriorating which is dangerous to the passers.

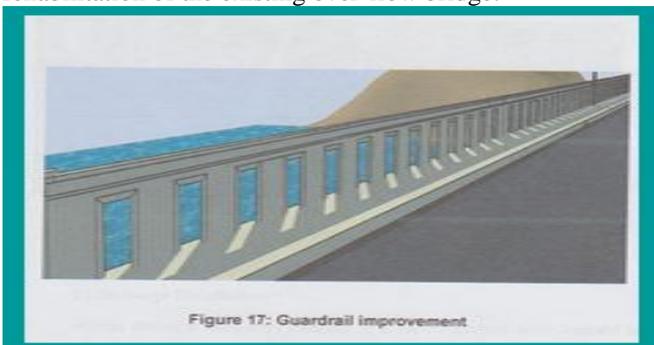
Figure 17: Guardrail Improvement

4.2. Damaged wheel guards as controlling part to prevent drawing of vehicles and motorists into the river.

Figure 12: Guardrail Improvement
