# Rehabilitation and Retrofitting of Old RCC and Steel Buildings: An Evidence-Based Assessment Framework with Two Case Studies

Vishal Prasad and Prashank Mani  
Department of Civil Engineering  
Cambridge Institute of Technology  
Ranchi, Jharkhand, India

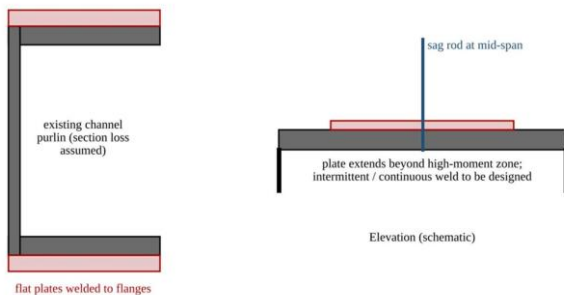
The assumed corrosion consumes most of the bending margin (DCR rising from 0.60 to 0.92) and brings the deflection close to the L/150 limit, and the plates restore the margin. This demonstrates the method only; it says nothing about the actual gantry, and stability and connection checks would still be required.

Fig. 4. Schematic of plate strengthening of a corroded channel purlin (concept only)
