# Stress Corrosion Cracking in CO<sub>2</sub> Compressor Intercooler

Prem Baboo  
DGM (Production & Process)

On dated 05/09/2017, the 3<sup>rd</sup> stage intercooler of CO<sub>2</sub> Compressor tubes were got damaged by stress corrosion cracking. The deep study was conducted with objective of how to developed crack on tubes.

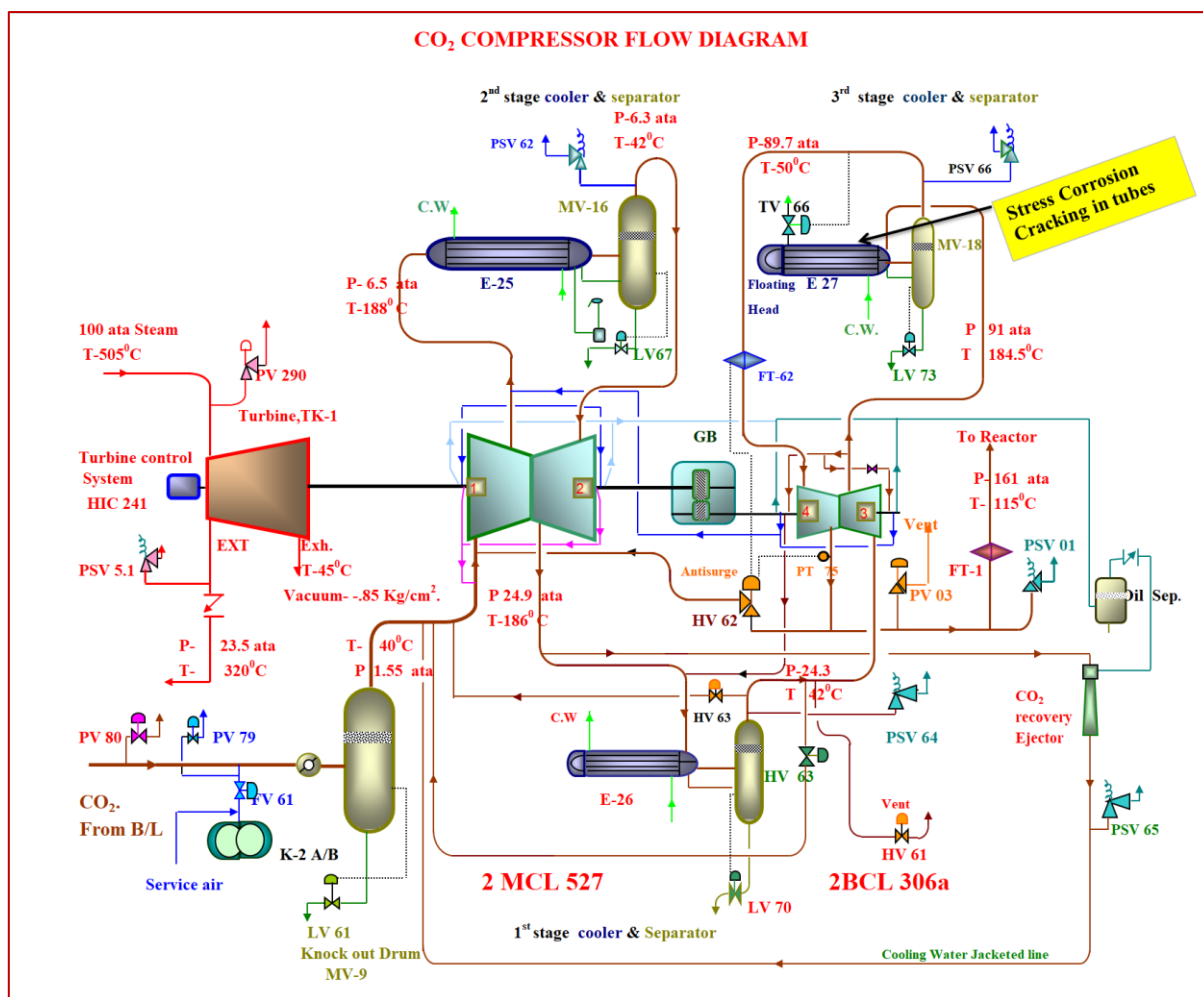
Fig-1(process Flow diagram of CO<sub>2</sub>Compressor)

1<sup>st</sup> stage-5.5-6.0 kg/cm<sup>2</sup>g ,2<sup>nd</sup> stage-22-23 kg/cm<sup>2</sup>g,3<sup>rd</sup> stage-87-88 kg/cm<sup>2</sup>g and final stage 160-161 kg/cm<sup>2</sup>g and temperatures are 1<sup>st</sup> stage disch-190°C,2<sup>nd</sup> satgedisch-182°C,3<sup>rd</sup> stage-175 and final discharge temperature 120°C the diagram as shown in the figure-1

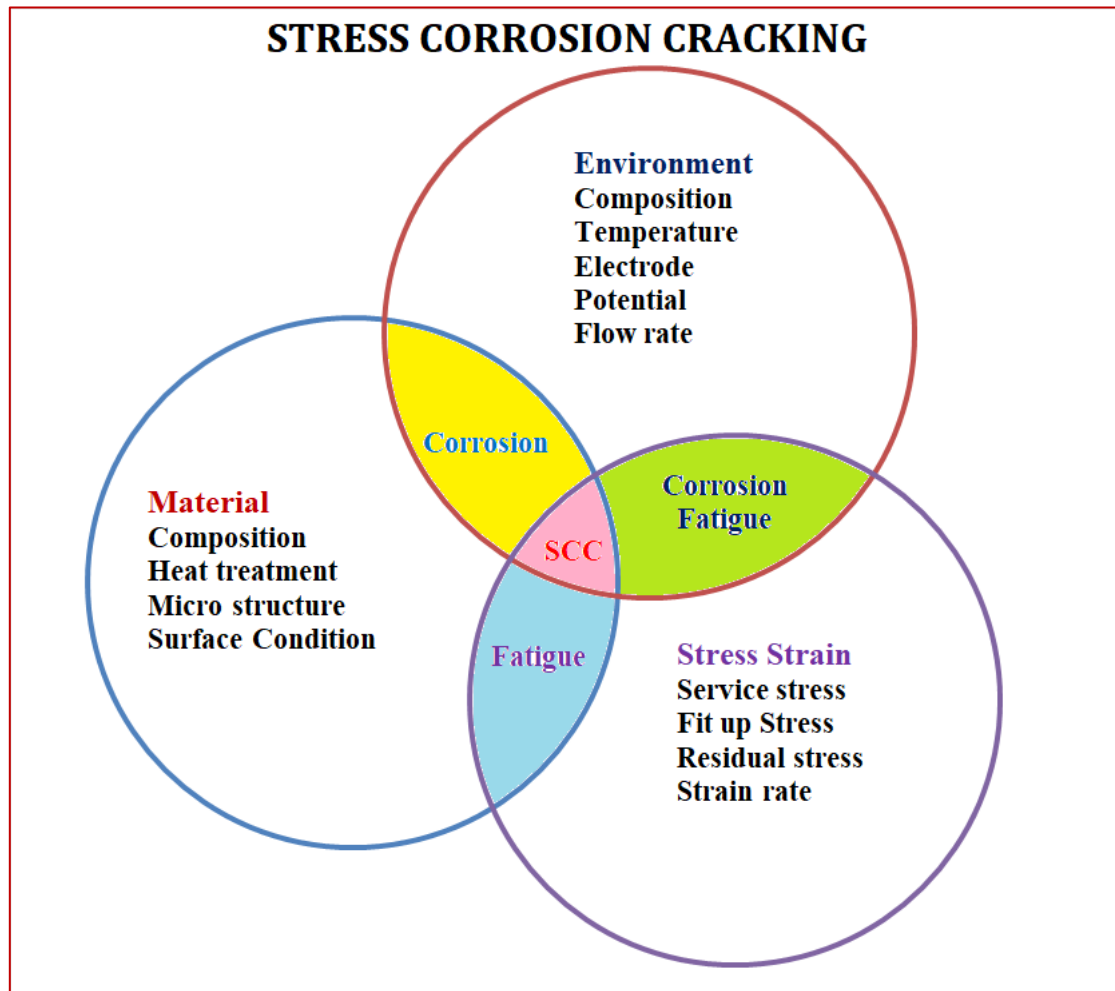
Fig-4 (SCC demonstration diagram), taken from <http://www.kemplon.com/wp-content/uploads/2014/10/logo.png>.

Stress Corrosion Cracking (SCC) is the progressive cracking of metals and alloys caused by the combined effect of SCC-Prone Microstructure, Temperature, Pressure and environments. Tensile Stresses High Enough to Induce SCC: sources of stress: SCC-Facilitating Environs: chloride, hydroxide, carbonate, bicarbonate, ammonia, aerated water, acetate, thiosulphate, phosphate, polythionate, and methanol. Temperature and Time exacerbate the effect of all the above causes. Acting alone, stresses or corrosive ambiances cannot induce SCC. SCC-infested metals demonstrate trans-granular or inter-granular cracks as shown in the figure-4. The affected material may fail without displaying any symptoms of an impending failure. Cracks penetrate deep into the material while the surface remains unaffected and the material fails with meager loss of material.
