# Construction Phase Road Safety Audit of Kottayam Ettumanoor MC Road (SH 01)

**Abstract**—The nation's highways are in need of extensive maintenance and reconstruction work. High traffic demand requires state and local transportation agencies to consider practical strategies for minimizing a work zones impacts on the travelling public and construction workers. Work zone safety audit is a proactive tool to serve the purpose. The procedure of road safety audit (RSA), can be incorporated in the framework of designing, constructing, and operating road infrastructure as a means for preventing accidents. This paper presents the guidelines for the highway work zone safety audit of Kottayam-Ettumanoor MC road at its construction stage. The construction activities being carried out there resulted in significant road safety issues essentially increase in number of road accidents. A Road Safety Audit was conducted for 11 km in the Kottayam - Ettumanoor road stretch and four black spots were identified. The major problems that challenge the safety aspect of the road were identified by a negative response survey and an switching response survey. On the basis of the results of Road Safety Audi

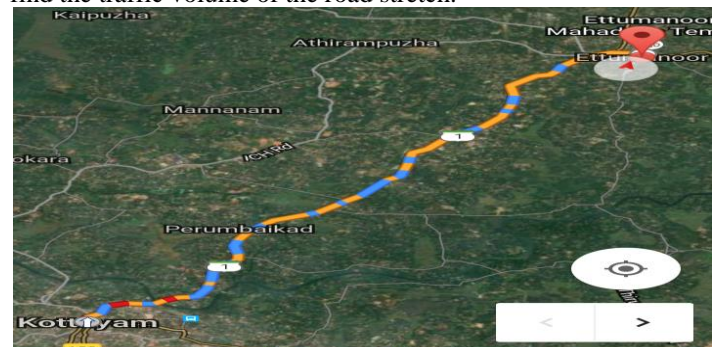
Fig 1. Study Stretch  
ACCIDENT DATA COLLECTION

Kottayam Ettumanoor MC Road is the study section of the state highway 01 where the road improvement works are in progress. The data collection included in the thesis work is: The cross sectional drawings obtained from the Kerala Public Works Department (PWD). The accident data of Kottayam District was collected from the Kerala State Crime Recording Bureau. The spot speed was measured using Radar speed gun. Both manual counting and video graphic method was used to find the traffic volume of the road stretch.

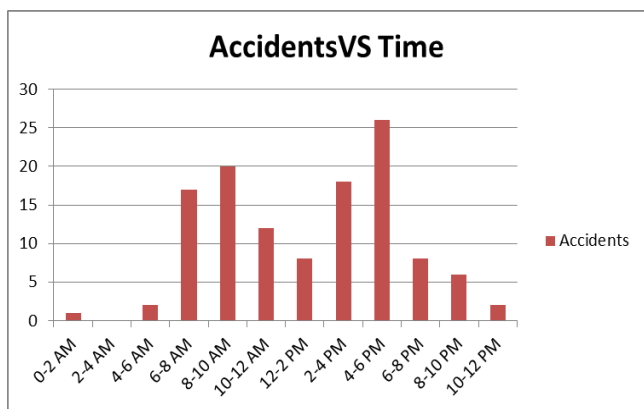
Fig 3. Number of accident vs. time period

It is found that during 10.00PM-08.00AM accidents occurred is very less. Peak time of accident occurring is during 06.00AM-10.00AM and 04.00PM-06.00 PM. it is found that total 89 accidents were occurred at the selected black spots during the period 2014 to 2016. Out of it 89 accidents 73 accidents occurred during the day time.
