Defect Classification and Technical Disposition of Aero Engine Hot-Section Anomalies: An MRB Approach

Abstract— The manufacturing of aero engines is a highly intricate, time-consuming, and costly process, carrying significant functional and safety implications. Among the most critical elements in hot section engineering are the rotor components, which operate under extreme thermal and mechanical loads. This paper identifies and categorizes various manufacturing defects in this domain, assigns their root causes, maps causal links and cascade effects, and introduces a comprehensive taxonomy system. A structured MRB-driven methodology is presented for classifying defects and determining the appropriate technical disposition of non-conforming components. The identified defects-gathered through direct observation during manufacturing and inspection- are categorized primarily into dimensional and visual types. Disposition decisions, such as acceptance as-is, rework, repair, or scrap, are made based on thorough engineering analysis, technical substantiation, and compliance with aerospace standards. The paper provides a single, illustrated, and standardized list of manufacturing defects a

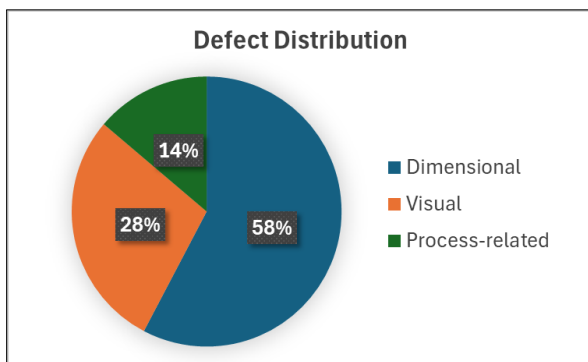
Fig. 3. Bar chart showing the percentage of recorded defects by category (Dimensional, Visual, Process-related).

In brief, Dimensional defects correspond to geometric or tolerance-related non-conformities such as diameter deviation, runout, or profile mismatch. Visual defects include surface imperfections such as scratches, dents, coating damage, and finish irregularities detected during visual or optical inspection. Process-related defects encompass anomalies arising from manufacturing or special-process deviations, including coating non-uniformity, oxidation, or heat-treatment inconsistencies. The quantitative distribution of these categories is summarized in Table II, and their relative frequencies are illustrated in Figure 3.

The analysis indicates that dimensional deviations account for approximately 58 % of the observed anomalies. This high proportion demonstrates that dimensional control remains the most critical challenge in the manufacturing of hot-section components, where tight tolerance requirements are essential to maintain aerodynamic performance and tip-clearance margins. Visual anomalies, representing about 29 % of the total, mainly include surface blemishes, coating chips, and handling-induced marks. Although many such defects are superficial and correctable through localized rework, they frequently trigger MRB evaluation because of their potential effect on coating adhesion and fatigue life. Process-related defects, constituting roughly 14 %, occur least frequently but often carry higher severity, as they originate from deviations in thermal or coating

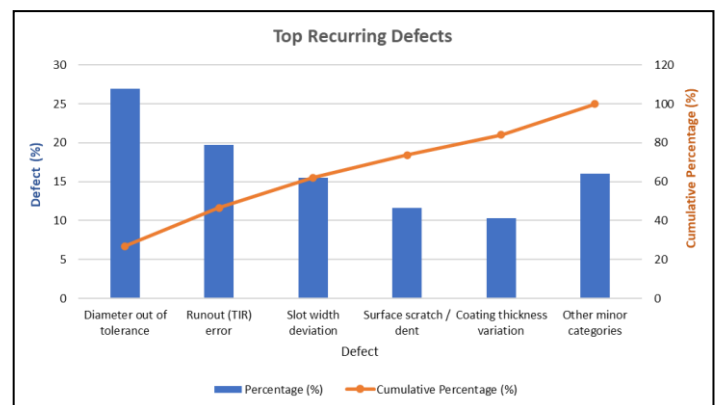
Fig. 4. Pareto chart of defect types ranked by percentage contribution to total anomalies.

A Pareto analysis was performed to identify the defect modes that most frequently contributed to MRB occurrences. Each unique defect type listed in the RCCA records (provided in appendix) was consolidated and ranked according to its relative frequency of appearance across all categories. The cumulative percentage of these ranked defects was then computed to determine the most recurrent anomalies and to highlight the few high-impact defect types that account for the majority of rejections. The summarized results are illustrated in Figure 4, and Table III.

The Pareto distribution indicates a highly concentrated pattern of defect occurrence, with a small number of recurring defect modes contributing to the majority of total anomalies. The five most frequently observed defect types - diameter out of tolerance, runout or concentricity deviation, slot or width variation, surface scratch or dent, and coating thickness non-uniformity collectively account for approximately 74 % of all recorded defects.

Among these, dimensional defects (diameter, runout, and slot deviations) dominate the upper portion of the Pareto curve, reflecting their direct dependence on tooling integrity, fixture stability, and measurement accuracy. Visual surface defects, such as scratches or dents, represent a smaller share of occurrences but remain critical because of their potential influence on coating adhesion and aerodynamic smoothness.

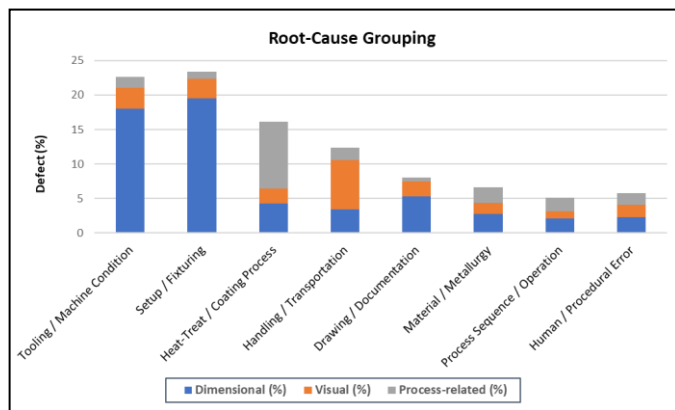
Fig. 5. Distribution of grouped root-cause categories across defect types (Dimensional, Visual, Process-related).

For uniformity and comparability, individual causes were grouped into eight higher-level categories that represent the principal origin domains observed in gas-turbine manufacturing: Tooling / Machine Condition, Setup / Fixturing, Heat-Treat / Coating Process, Handling / Transportation, Drawing / Documentation, Material / Metallurgy, Process Sequence / Operation, and Human / Procedural Error. This consolidation was performed following the structured classification approach detailed in appendix, where each RCCA entry is traceable to its specific root-cause group and corrective action. The percentage distribution of these grouped causes is summarized in Table IV and visually represented in Figure 5.
