# Diagnosing and Resolving Address Conflicts in Addressable Fire Alarm Systems: A Field-Based Technical Approach

Peniel Malwena Tshikumba, Zhong Sheng  
Technical Support Engineer – Fire Alarm Systems  
Shenzhen Tanda Technology Co.,Ltd.

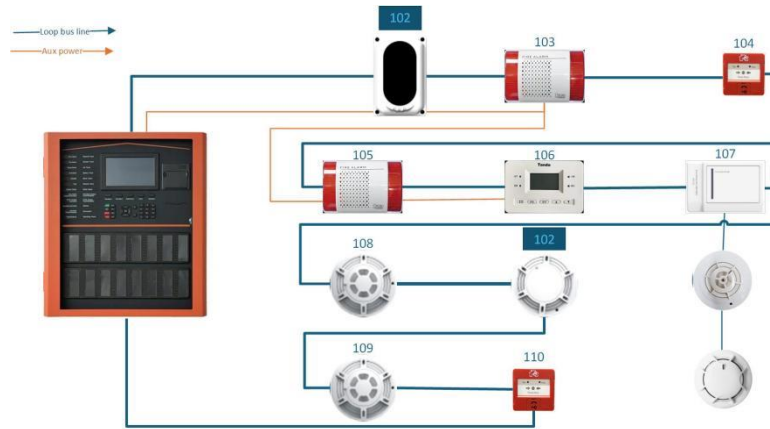
Figure 1. Diagram of a signaling line circuit (SLC) showing two devices with the same logical address (102), resulting in communication ambiguity.

- Two or more devices on an SLC share the same address - A mismatch exists between the device's programmed address and its physical configuration - Cross-loop duplication introduces ambiguity into system communication

Consequences include: - Unresponsive or malfunctioning devices - Repeated error notifications ("device missing," "device trouble") - Inaccurate event location reporting - Missed or delayed alarm activation  
Address conflicts may go unnoticed during routine checks, making comprehensive diagnostics critical.

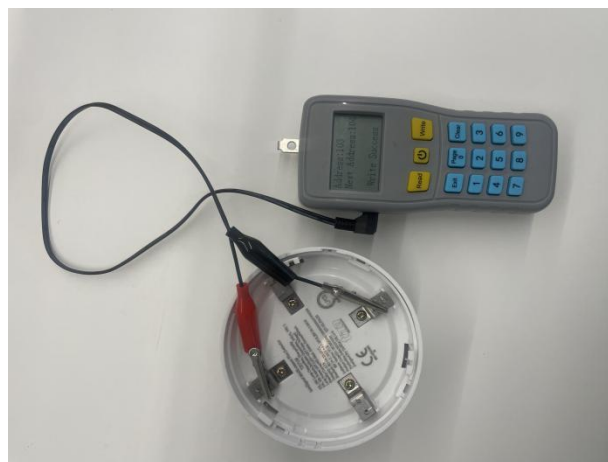
Figure 3. Handheld programmer being used to read and modify device addresses on-site.

Tool	Function
Loop Tester	Detects address duplication and loop faults
Handheld Programmer	Reads/writes address settings on-site
Installation Plans	Confirms intended addressing and physical layout
Control Panel Software	Allows device mapping and reconfiguration
