# To Reduce the Rejection Of H4 Halogen Lamp At Sealing Stage By Proper Pinch Seal

\*Sharad Shrivastava \*\*D.S.Kumani  
Poornima College of Engineering, Jaipur

*This report gives the quality improvements that are needed to reduce the defects at the "Sealing stage" of manufacturing Halogen Lamps at M/S Autolite (India) Ltd, Sitapura, Jaipur. The Sealing process of manufacturing Halogen Lamps was studied and the problem areas that contribute more significantly to defects were identified using fish bone diagram. The major contribution in defectives is due to process inconsistency in pinch seal formation due to improper alignment process, tilting of mount, press hammer pressure and annealing temperature. By removing the above process inconsistency after detailed study and observations, significant quality improvements were observed and the defects at sealing stage were reduced from 3.8 % to 1.82 %*

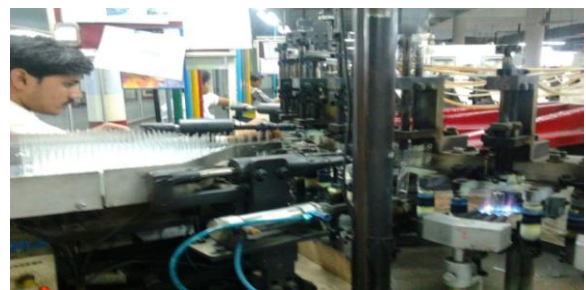
**Fig 1; Bulb Shell Tube Feeding**

In Autolite (India) Limited, Jaipur 36 head Turret machine is used for sealing the mount with bulb glass tube. In this process tabulated bulbs are loaded into the upper Fixture and mounts are loaded into the lower Fixture of the turret head at respective Insertion station of machine feeding system. The Bulb shell is dropped down over the mount by Bell crank lever arrangement operated with the help of Special Cam mechanism and mount is hold by mount holding jaw for correct positioning before the first burner for heating.

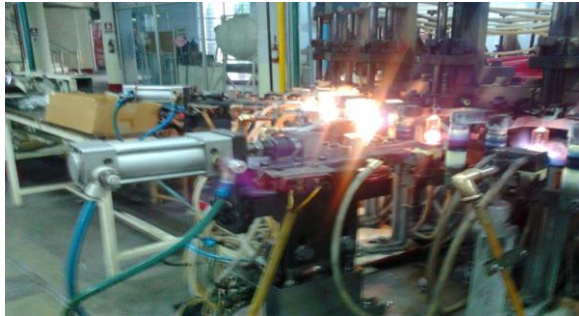
**Fig.2: Stainless Steel Pressure pads**

temperature is continuously increased by burners. Between burner station No.11 and burner station No.12 when final temperature gains is  $1800^{\circ}\text{C}$  final leak proof seal develops between glass bulb shell and mount be produce by pressing them with second Stainless steel press pads.

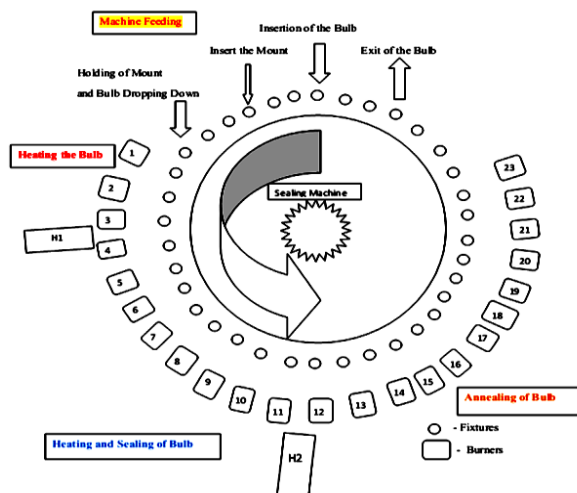
**Fig.3: Layout of Sealing machine**

The heating of Bulb shell is done by Burners in increasing order of temperature from room temperature to 1800 °C at Burner station No.1 to Burner Station No.11 for sealing. From burner station no.2 to Burner Station no.11 air and LPG are used for producing the flame for heating the bulb, Between Burner station No.3 and Burner station No.4 Stainless steel press pads (hammer) are used to change the circular shape of bulb into rectangular shape and producing first pinch, then from Burner station No.4 to Burner station No.11

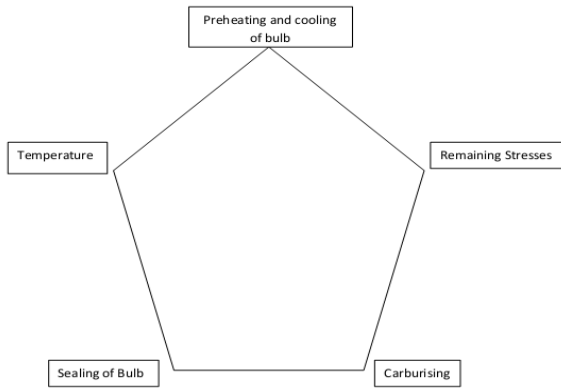
Fig.5: Parameters

1. Temperature
2. Preheating & Cooling Effect
3. Remaining Stresses
4. Sealing of bulb shell
5. Carburising of bulb shell

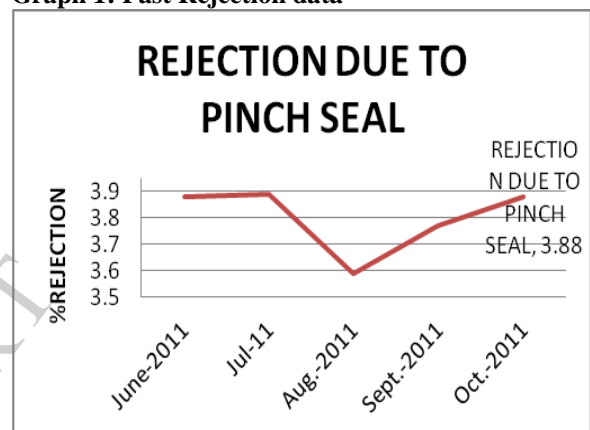
Graph 1: Past Rejection data

These all defects are observed and examined on the sealing machine, after that the rejection of each defects recorded from June 2011 to Oct 2011 .These are following:-

Month	Pinch Seal	Annealing	Hammer pressure	Total Rejection
June-2011	3.88	0.462	0.778	5.12%
July-2011	3.89	0.459	0.811	5.16%
August-2011	3.59	0.45	0.82	4.86%
September-2011	3.77	0.42	0.75	4.94%
October-2011	3.88	0.39	0.75	5.02%
Mean	3.80%	0.44%	0.78%	5.02 %

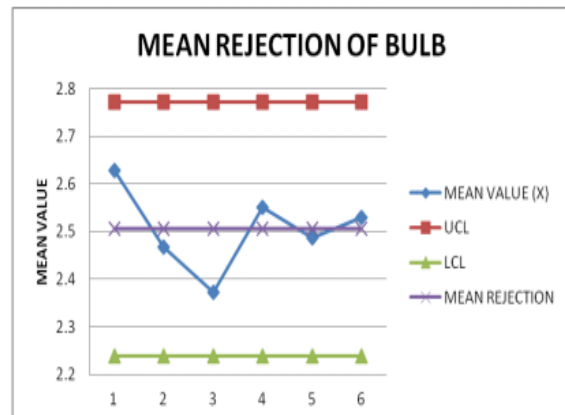
**Graph 2:X-Bar chart with their limits**

S.No.	SAMPLE SIZE (5)	MEAN VALUE (x̄)	UCL	LCL	MEAN OF REJECTED BULB
1	x̄ <sub>1</sub>	2.628	2.772	2.239	$\bar{x} = \frac{\bar{x}_1 + \bar{x}_2 + \bar{x}_3 + \bar{x}_4 + \bar{x}_5 + \bar{x}_6}{5} = 2.506$
2	x̄ <sub>2</sub>	2.468	2.772	2.239	
3	x̄ <sub>3</sub>	2.372	2.772	2.239	
4	x̄ <sub>4</sub>	2.552	2.772	2.239	
5	x̄ <sub>5</sub>	2.488	2.772	2.239	
6	x̄ <sub>6</sub>	2.53	2.772	2.239

After the constant observation and analysis of the statistical data of total bulbs produced and rejected in every month from June 2011 to March 2012, the percentage of rejected bulbs with individual defects (before and after measures implementation) was obtained, after plotting the graph found that the mean rejection on sealing machine decreases from 3.8 % to 1.82 %. On the basis of rejection data on sealing stage of Nov.2011, calculating and observing the Mean ,Upper control limit and lower control limit ,it was found that the process is within the control condition under significant manner.

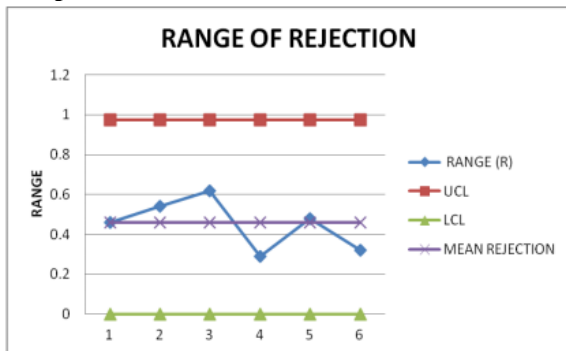
**Graph 3: R-Bar chart with their limits**

SAMPLE No.	RANGE (R)	UCL	LCL	MEAN RANGE $\bar{R}$ OF BULB REJECTED
1	0.461	0.975	0.0	$\bar{R} = \frac{R1+R2+R3+R4+R5+R6}{6}$ $=0.461$
2	0.54	0.975	0.0	
3	0.62	0.975	0.0	
4	0.29	0.975	0.0	
5	0.48	0.975	0.0	
6	0.32	0.975	0.0
