Rehabilitation of Structural Members

Abstract—In this project non destructive leakage detection method is adopted to detect early leaks that are not possible to detect through visual examination. The purpose of this work is to increase the durability of the building, avoid damages and minimize the energy consumption in repairing of water leaks on building. The leakage detection methods done are focused on cost effectiveness. The leak detection method uses infrared sensors to detect the water leaks in structural members. The temperature variation gives a colour change and thus the leaks are detected. The solution for water leak is prescribed. The sealing material is tested for water proofing property by impermeability test and it is applied on the existing damaged structure and the source of water leak is thus arrested. Thus the leak is sealed and the life of structural member is increased.

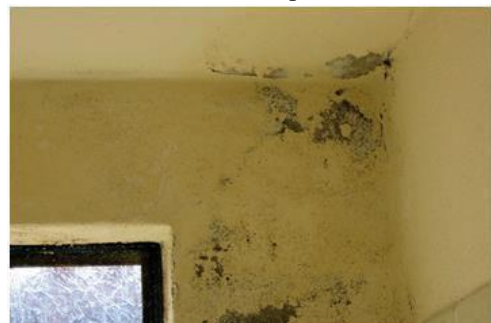
Fig.1. Image showing damages occurred in roof and wall due to water leakage

When hidden leaks go undetected, the problem threatens property values, your utility costs increase, and repairs become more costly. Small punctures, membrane splits or mechanical damage to waterproofing membrane result in wet insulation, mold, and costly interior damage. Leaks can go unnoticed and the water exit location might not correspond with the point of entry. Thus leak detection is an important criterion.

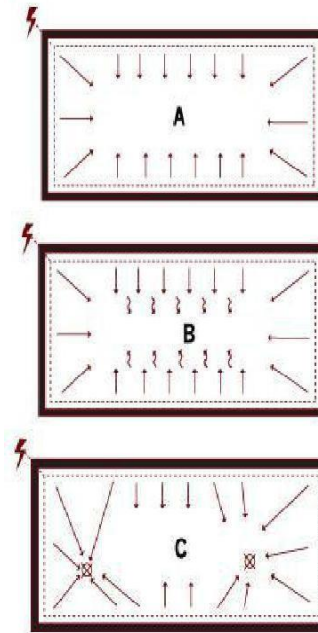
A. Small electrical pulses are directed onto the membrane. The electricity searches for a ground connection.

B. If the membrane is watertight, the electricity is isolated and does not find a ground connection.

Fig. 1. PRINCIPLE OF EFVM

C. If the membrane is not watertight, the electricity makes a ground connection and is pulled toward positive poles.

An electric field is created by applying water on the surface of the membrane and using the water as a conductive medium. The EFVM equipment delivers a low voltage pulsating electrical charge between the non-conductive waterproofing membrane and the conductive structural deck. A watertight membrane will isolate the potential difference, while breaches in the membrane will cause an electrical connection to occur. The inspectors read the directional flow of the current with a potentiometer to locate the point of entry with pinpoint accuracy. The EFVM technicians then complete the test by conducting a visual inspection of all wall junctions, perimeter details, and membrane penetrations. All breaches are numbered to allow for repairs by the water proofers onsite and are retested to confirm water tightness. Small electrical pulses are directed onto the membrane. The electricity searches for a ground connection. If the membrane is watertight, the electricity is isolated and does not find a ground connection. If the membrane is not watertight, the toward positive poles.

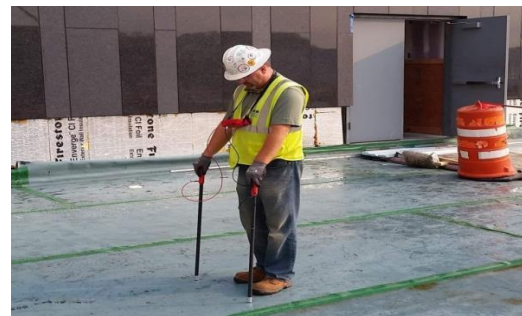
Fig.2. EFVM testing for leakage in roof

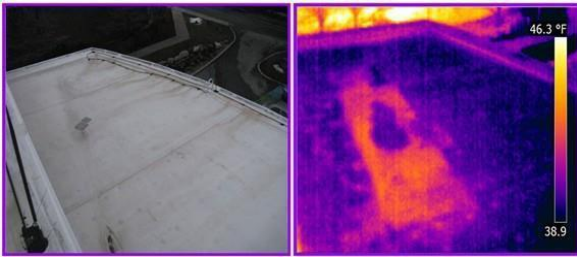
This is the method in which the IR rays produced by the body is received by the IR receiver and based on the temperature increase or decrease with reference to the reference temperature, the leaks in the members can be detected. An infrared inspection of your roof can detect evidence of latent moisture within your roof cavities and it can determine the potential for ice dams, plugged drains, and water retention that may cause roof damage and/or leakage which could lead to serious damage to your living area if not detected on-time. By infrared roof evaluation you can save a bundle (in the long run) by knowing if certain roof sections need minor repair now to avoid major repair or replacement later, or to simply determine if the whole entire roof needs to be replaced in the not-so-distant future. Thermal imaging can give you the existing roof information in a nice neat visual package. This roof looks great visually, but a major moisture build-up detected utilizing infrared camera

Fig.3. IR Imaging

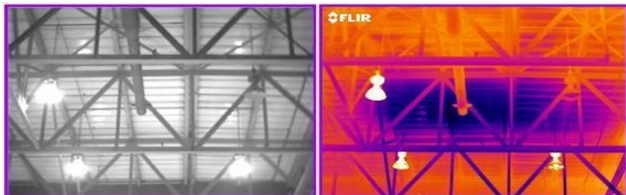
Fig.4. IR Imaging of Roof Truss

During a home inspection, roof leaks are typically discovered by direct observations, roof and then confirmed by utilizing moisture meters on the sheathing below. But if we detect a moist area and the roof sheathing is not visible from below (such as a finished cathedral ceiling or a ceiling below a living area) the exact area of the leak cannot be determined. Then the floor must be protected from the falling debris and possibly requiring a scaffold system. Then once we pinpoint the problem area, minimum surface areas can be removed in order to make the necessary repairs. It is good to prefer to perform all exterior flat roof inspections in the early evening hours. In order to perform the infrared inspection correctly, we require solar heating of a hot sunny day to heat up the roof surface.. If water is actively seeping into the cavity of a roof surface, the dry roof insulation will cool much faster than the soggy wet roof insulation, making it possible for me to observe the thermal differences. Regularly scheduled infrared roof inspections will allow you to find moisture damage and water leaks that have not yet become apparent. This is the most cost-effective approach to any roof maintenance.

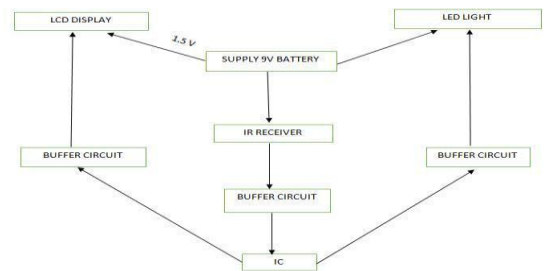
The equipment consists of a LED light, IR receiver, IC chip and a printed circuit assembly which consists of resistors, capacitors and transistors. All these are connected to a power supply which is the battery. The battery used is a 9V battery. The red and black wires form the positive and negative poles respectively. These wires are connected to the IR emitter and the LED light through 3pin (which includes the wire from the IR emitter that carries the information about the temperature to the IC) and 4pin (which includes wires from the IR emitter and the IC). It consists of one polarized capacitor of 33µF (i.e. the capacitor consists of positive and negative) and many non-polarized capacitors. The polarized capacitor is mainly for the

steady power supply and other capacitors for noise filtering. The resistors are for the voltage drop and increase if the sensitivity of the device is adjusted.

Once the 9V battery is connected and the power button is switched on the device starts to temperature of the body to which the device is focused. So the power button is switched on and the IR receiver is focused to the body with respect to which the reference temperature is fixed by the device. The reference temperature is indicated by the green colour light from the light source. These commands are given by the IC. Now the device is moved throughout the place where the leakage has to be checked. The IR rays emitted by the body are continuously received by the IR receiver and the temperature change is constantly displayed in the LCD display. If the temperature reduces from the reference temperature, there will be an indication by means of the LED light i.e. it turns to blue colour. If the temperature of the body goes beyond the reference temperature, then the light turns to red colour. There are 3 forms of sensitivity i.e. the sensitivity of 1-degree change in temperature, 5-degree change in temperature and 10-degree change in temperature. There also a sensitivity adjustment in which there will be no LED light indication.

Fig. 6. Block diagram of detector equipment

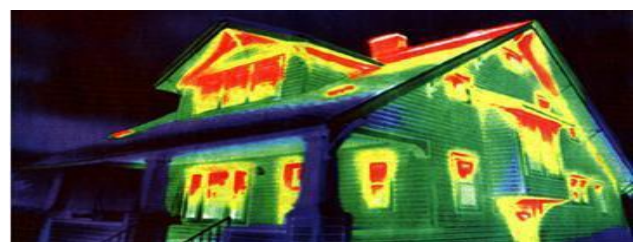
The device is focused to the place where the leakage detection has to be made. The sensitivity is adjusted. Based on the temperature and colour change the leakage can be confirmed.

Fig.7. IR testing for leakage in building
