Experimental Investigation of Mineral Composite Bonder over CFRP and GFRP Retrofits

Raghavendra Vasudeva Upadhyaya
Research Scholar: Engineering and Technology
Central Queensland University
Rockhampton, QLD, Australia

T. G. Suntharavadivel
Lecturer: Engineering and Technology
Central Queensland University
Rockhampton, QLD, Australia

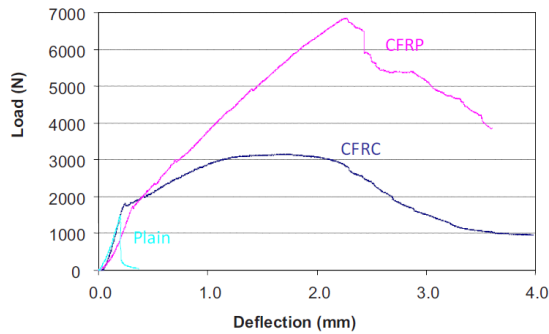
Fig. 1. Flexural response of plain, CFRC and CFRP retrofit

Mineral based composites (MBC) involves the replacement of epoxy resin binder by a cementitious mortar containing admixtures like superplasticizers, viscous modifying agents, strengthening additives, etc. It should provide excellent bonding properties, along with good workability, cost efficiency and most importantly compatible with most of the FRP retrofits. The investigation of mechanical behavior performed by [4] for Carbon Fiber Reinforced Composites (CFRC), plain and mineral based composite retrofitted beams to calculate their flexural behavior. As shown in Figure 1 the plain beam showed a brittle failure whereas the fatigue resistance of CFRC and Carbon Fiber Reinforced Polymers (CFRP) retrofitted beams significantly increased. In the end, unlike CFRP retrofitted

beam, CFRC failed due to rupture of the sheet and not due to delamination.

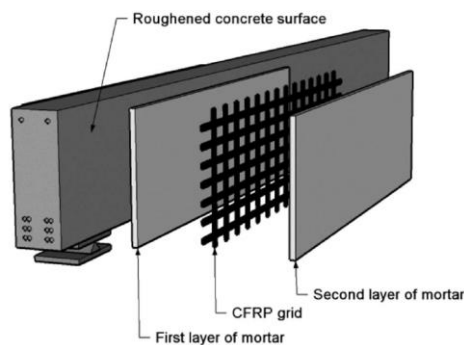
Fig. 2. Overview of Mineral based strengthening system

[5] studied FRP bond strength in a single-lap (see Figure 2) shear and flexural tests. The bond-slip response identified made it clear that cement-based bonding materials are an effective technique in hot regions or in places where there is a danger of fire. This was because the ultimate load was 80% greater than CFRP retrofit with epoxy bonding.

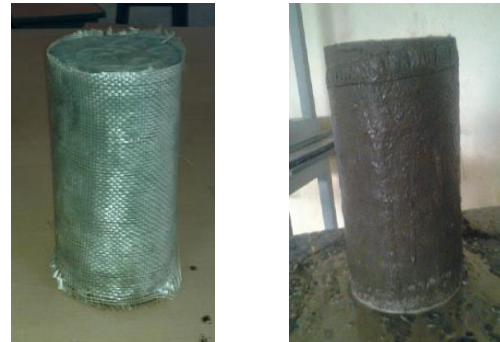
Fig. 3. GFRP wrapped specimen with epoxy and MBC bonders

After the samples are cast and cured, their outer surface needed to be prepared before application of retrofit. Firstly, the specimen is sun-dried to remove all the moisture in them. Later, the surface is smoothed by grinding or by use of a sandpaper and the loose particles are cleaned out with a brush. One coat of epoxy or MBC bonder is applied to the surface and the bi-directional fiber was wrapped tightly. E-glass fiber is known for its woven roving, the resin-reinforcement ratio rule is 1:1 by weight. Glass Fiber sheet is used here because of

its compatibility with most of the resins and ideal for multi-layer solutions. The specimens with epoxy and MBC bonder are shown in Figure 3.

All retrofitted specimens are subjected to single wrap retrofit. The wrapping had an overlap of 75mm to avoid failure in the overlap region. Then, the second layer of bonder coating is applied to the FRP surface to seal it properly and the setup is cured for 7 days

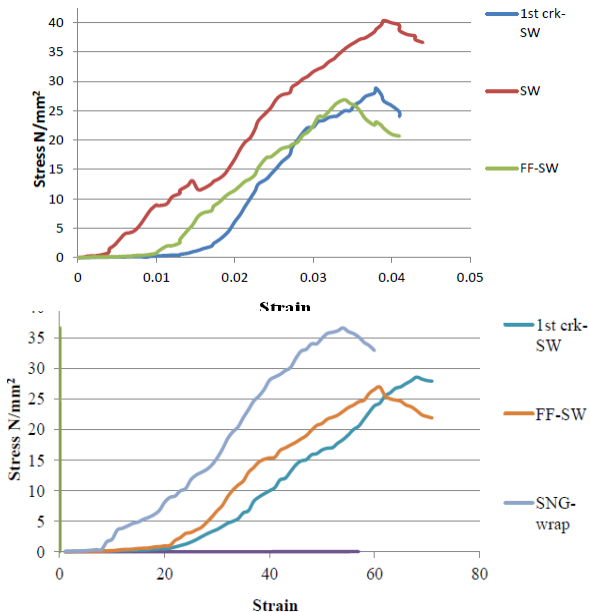
Fig. 4. Stress-strain plots for GFRP single wrap epoxy and MBC specimens

A stress-strain plot is also obtained for GFRP under compressive loading condition is shown in Figure 4. This plot also verifies that the behavior is very similar in both epoxy and MBC retrofitted samples with pre-existing damage.

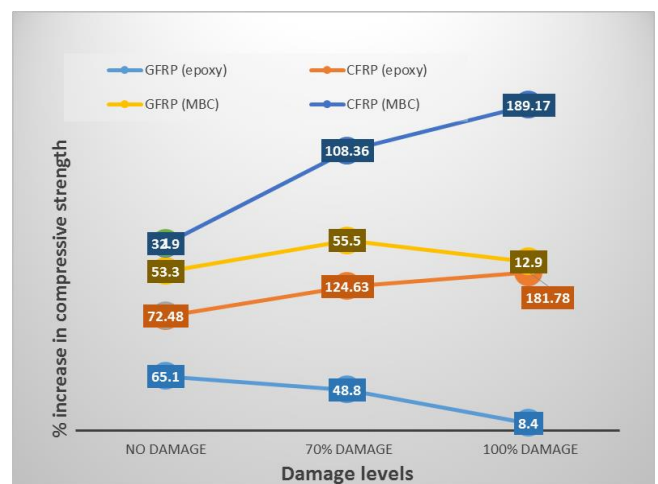
Fig. 5. Epoxy vs. MBC strength increase during compression testing

From Table 7 it can be seen that the epoxy exhibited lower standard error compare with MBC samples. That means epoxy results are more consistent compared with MBC. This variability also can be seen in other cement-based materials. From the above data, it is also distinctive that GFRP retrofit has a relatively greater range of accuracy with both bonding agents compare to CFRP. Therefore, it can be noted that both FRP sheets can improve their bonding capacity when the level of damage increases in the structural member and MBC admixture is more suitable with CFRP than GFRP because of its mechanical properties. The increase in compressive strength for both types of FRP specimens at various damage levels is illustrated in Figure 5. It is proven that the graph always progresses in case of CFRP whereas higher damage levels can lead to catastrophic failure in case of glass fibre.

Moreover, it is verified that CFRP dominates in performance over damaged specimen whereas GFRP is more suitable for a new specimen. Overall, it is suggested that mineral composites act as a better replacement as their characteristic strength has up surged up to 1.5 times in contrast to epoxy during a full failure condition.

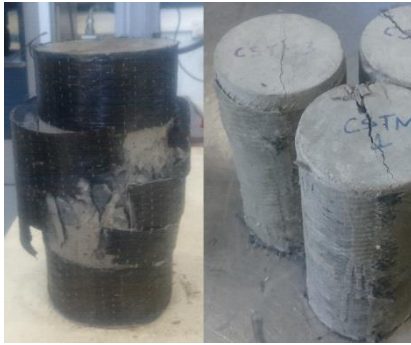
Fig. 6. Failure mode of single wrapped full failure CFRP specimens

In order to understand the failure type of the retrofits the failed specimens are shown in Figure 6. From the figure, it can be seen that the epoxy retrofitted samples failed due to rupture in the middle while delamination occurred in MBC retrofit samples along the previous failure path. However, the strength increase is very similar, except a slight increase in MBC retrofitted samples. This suggests MBC can be a suitable replacement for epoxy with further investigation to improve the bonding property.

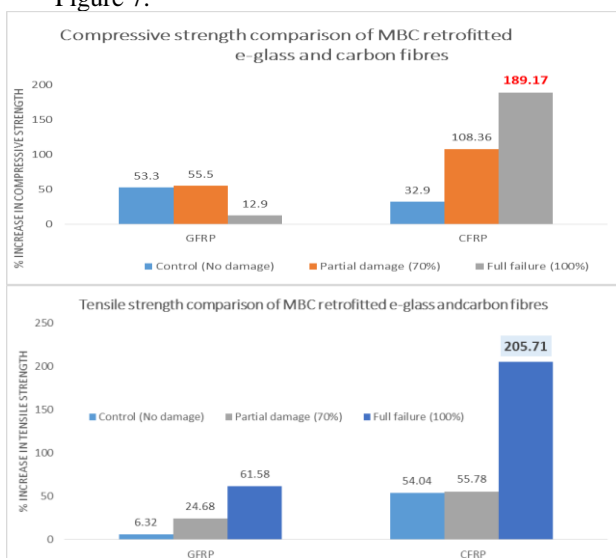
Fig. 7. Mechanical behaviour of MBC retrofitted FRP specimens

- The bonding behavior of FRP strengthened specimens using both epoxy and MBC have very similar behavior in most of the cases
- MBC retrofit showed up to 15% superiority in compressive strength for single wrap GFRP compare to epoxy. Whereas, on the other hand, CFRP retains similar behavior and bonding characteristics to that of GFRP retrofit except for around 200% increase in fully damaged tensile MBC retrofit as presented in Figure 7.
