# Special Materials for Rehabilitation of Monuments

**Abstract-** Monuments have been created for thousands of years and they are often the most durable and famous symbols of ancient civilizations. These are the icons of the nation having their own cultural and historic values therefore, it is very essential to conserve them. Each monument has its special design and decorative finishes and its own peculiar conservation problems which need innovative solutions. The deterioration of the structures takes place due to pollution, weathering action, fire, natural calamities like earthquake, flood, tsunami, cyclones, soil and structure interaction (Settlement of soil etc.), defects in construction and many more. This is going to be a great loss for the nation as the monuments are the important landmarks of the nation. Depending upon the look of the parent structure it is necessary to select the right material for the rehabilitation. New material should be compatible to the existing material in the structure. This paper will help to know the available materials that can be adopted for the rehabilitation of the monuments so that its aesthetic look is not changed.

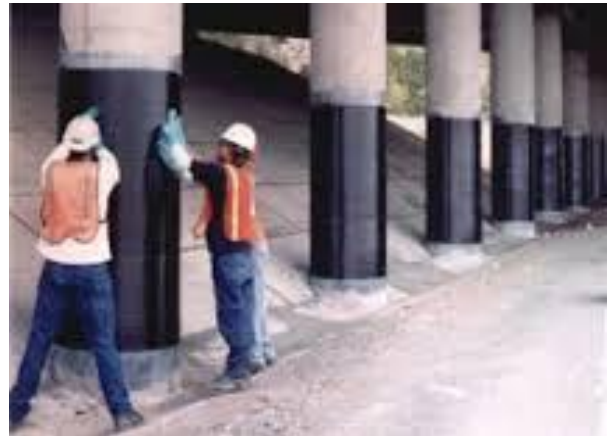
Fig.1 Wrapping of FRP.

FRP sheets are wrapped around the columns, with fibers oriented perpendicular to the longitudinal axis of column and are fixed to the column using epoxy resin. It is easy to install like putting up wallpapers.

The original size, shape and weight of the member remain unaltered (unlike any other jacketing method) therefore; this method is particularly useful for strengthening historic and artistic masonry structures. FRP provides minimum disturbance to the existing structure. The strengthening work can be performed with normal functioning of structure.

For strengthening of members materials like FRP can be useful rather using jacketing of the members. Epoxy can be used for better strengthening instead of using cementitious grout. While using these materials or techniques, compatibility of the new materials with old materials should be checked properly. And a periodic maintenance should be adopted.

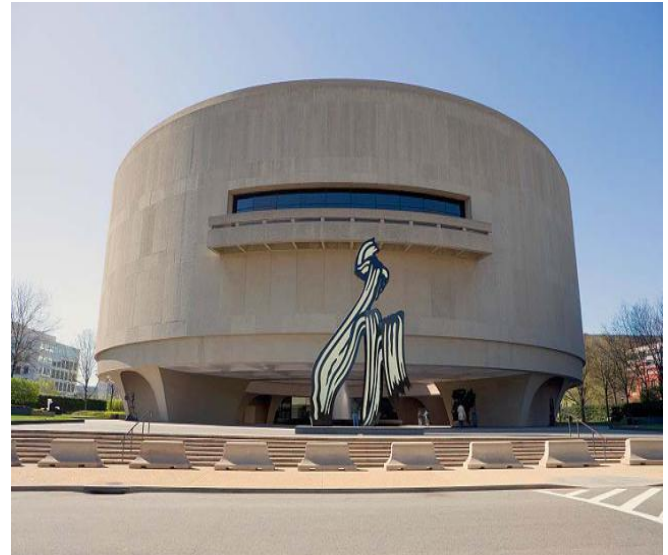
Fig. 2 The Hirshhorn Museum of art building

A very good example of failure due to use of non-compatible materials, is rehabilitation of The Hirshhorn Museum of art building (U.S.), which is explained by Mr. Boyd[1] in his research paper.

In 1993, in this building, certain crack began to enlarge due to the leakages in the building members. It was decided to use the method of pressure injection with epoxy but number of attempts disappointed the engineers. Epoxy has been found to penetrate only to a shallow depth where the epoxy can penetrate to any degree and any moisture content within the crack. Then the alternate method of vacuum technology was adopted.
