# Water Quality Assessment of Bellandur Lake in Bangalore City, Karnataka, India

**Abstract-** Lake water is a source of drinking and domestic use for rural and urban population of India. The aim of current study was to assess water quality of Bellandur Lake water, Bangalore. For this, lake water samples were collected from twelve different locations on the basis of their importance were analyzed for the parameters like Temperature, Colour, Turbidity, Electrical Conductivity, Total Dissolved Solids, pH, Total Hardness, Calcium, Magnesium, Alkalinity, Sulphate, Nitrate, Chloride, Phosphate, Fluoride, Dissolved Oxygen (DO), Biological Oxygen Demand (BOD) and Chemical Oxygen Demand (COD). Some heavy metals i.e., Iron, Zinc, Cadmium, Nickel, Chromium, Copper, Arsenic and Lead were also analyzed. The study report discusses about the analysis of lake water quality.

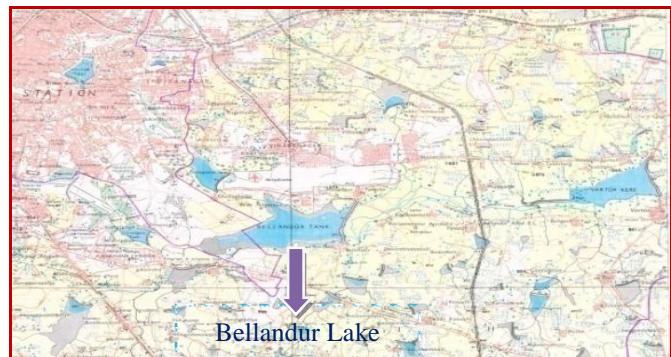
Figure 1. Extract of Topo sheet 57 H/9 showing the Bellandur Lake

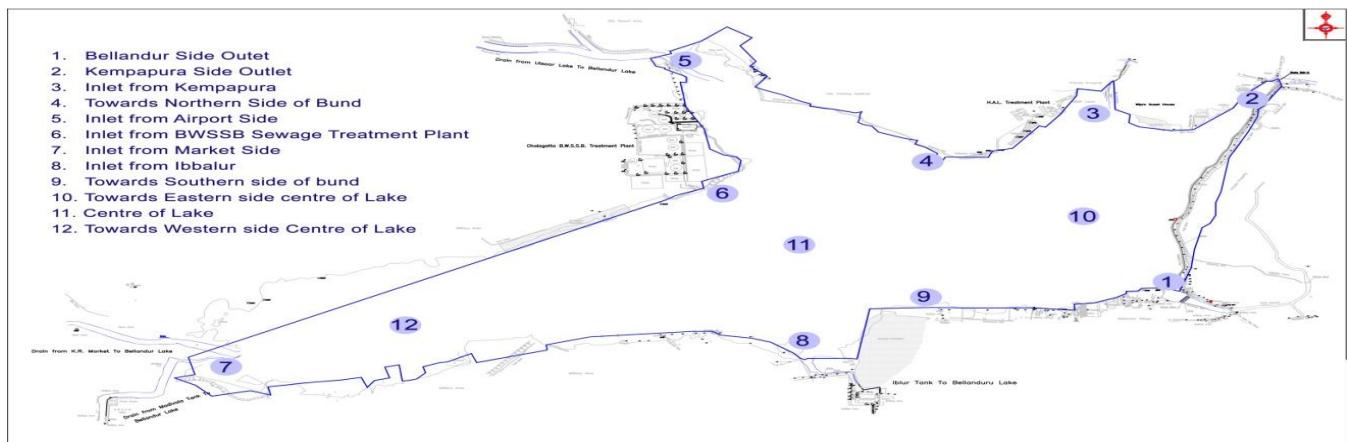
Figure 3. Sampling locations of Bellandur lake

Surface water samples for investigations were collected from twelve different sites selected which covered the whole area of the lake during March 2013. Grab samples of water were collected in Polyethylene bottles (2000 ml) were filled with lake water. The sampling locations are shown in Fig. 3. All samples collected were immediately delivered to the analytical laboratory for analysis. The analysis of the following physico-chemical parameters and some heavy metals was carried out using standard methods [10]. Temperature ( $^{\circ}C$ ), Colour, Turbidity (NTU), Electrical Conductivity (EC -  $\mu$ s/cm), pH,
